(NASA-CR-183585) SPACE STATION PROTECTIVE
COATING DEVELOPMENT Final Report (Boeing
Aerospace Co.) 304 p CSCL 22B

SPACE STATION PROTECTIVE COATING DEVELOPMENT

Final Report

**Contract NAS8-36586
January 1989**

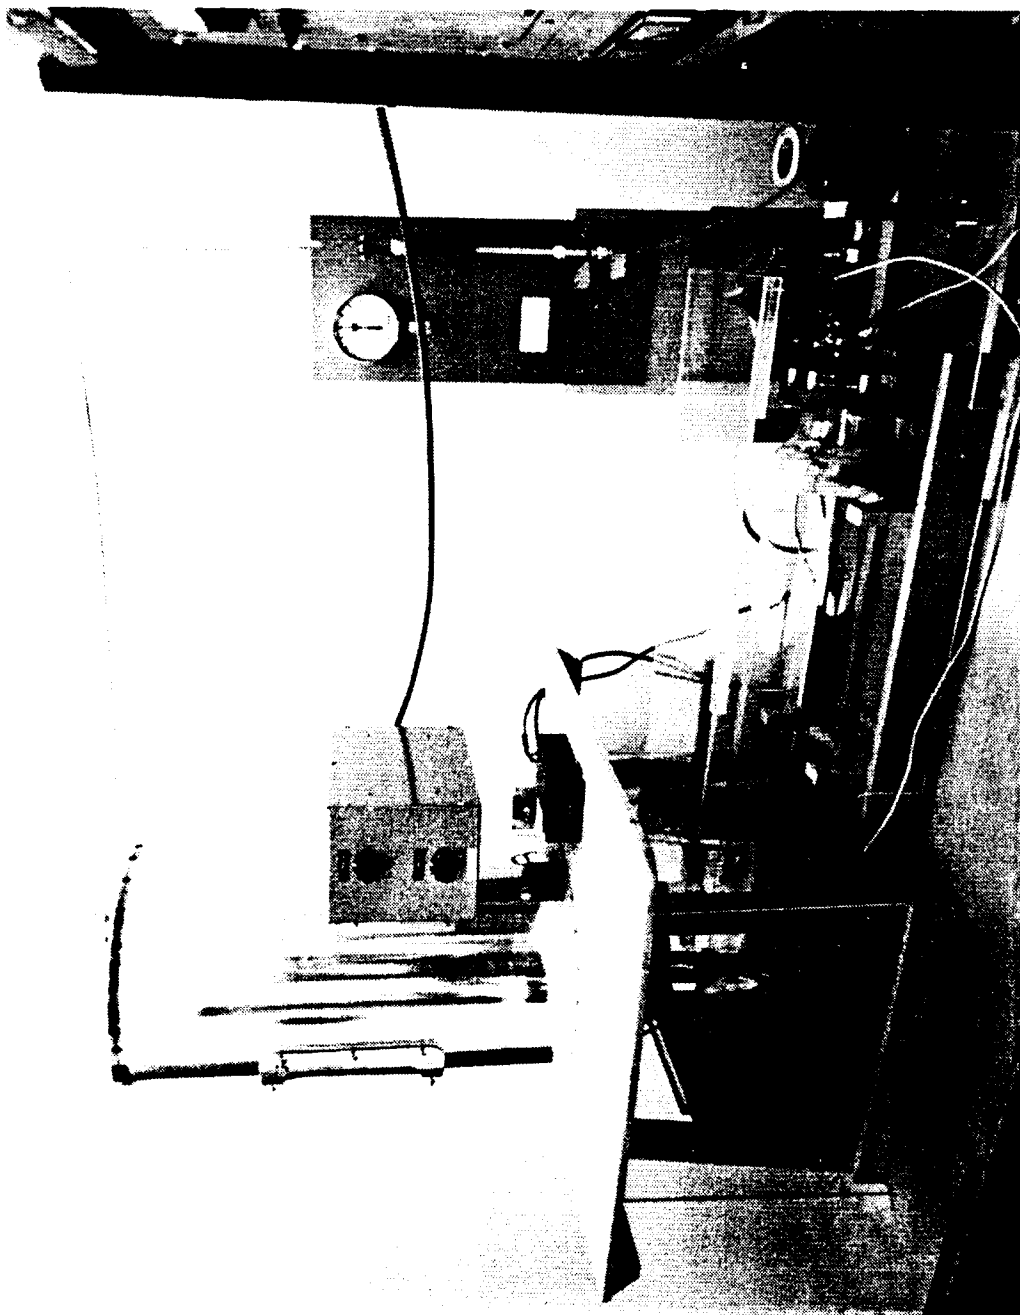
Figure 1: Original Configuration of Atomic Oxygen Test Apparatus

The initial test facility was the vacuum chamber shown in figure 1. The oxygen was produced in a radio frequency discharge induced plasma. Due to the nature of the circuit, the RF was present throughout the chamber and thus the plasma glow was sustained virtually throughout the vacuum chamber to the valve opening to the vacuum pump. In this configuration, the samples were exposed to the RF field, the ions associated with the plasma, emission of UV, and excited state neutral oxygen atoms and molecules, as well as the ground state oxygen atoms of interest. This chamber was a very harsh test environment and suffered from the fact that the different environmental factors were not well separated or well characterized. Materials tested in this environment were also subjected to severe heating due to the susceptibility of the aluminum sample holder. Table 5 is a summary of all the mass loss data and exposure conditions for tests with this apparatus. The pressure for these early experiments range between about 360 and 460 millitorr. The sample temperature was difficult to ascertain. A standard type K thermocouple placed within the chamber provided a reading of about 450°C for the temperature of the sample holder. Measurements taken as soon as possible after shut off of the RF and venting the chamber to atmosphere provide a reading of just over 200°C. Given the facts that the sample holder is cooling during the vent and that the thermocouple is heated by the RF field, the sample holder was estimated to be about 350-400°C during the exposure.

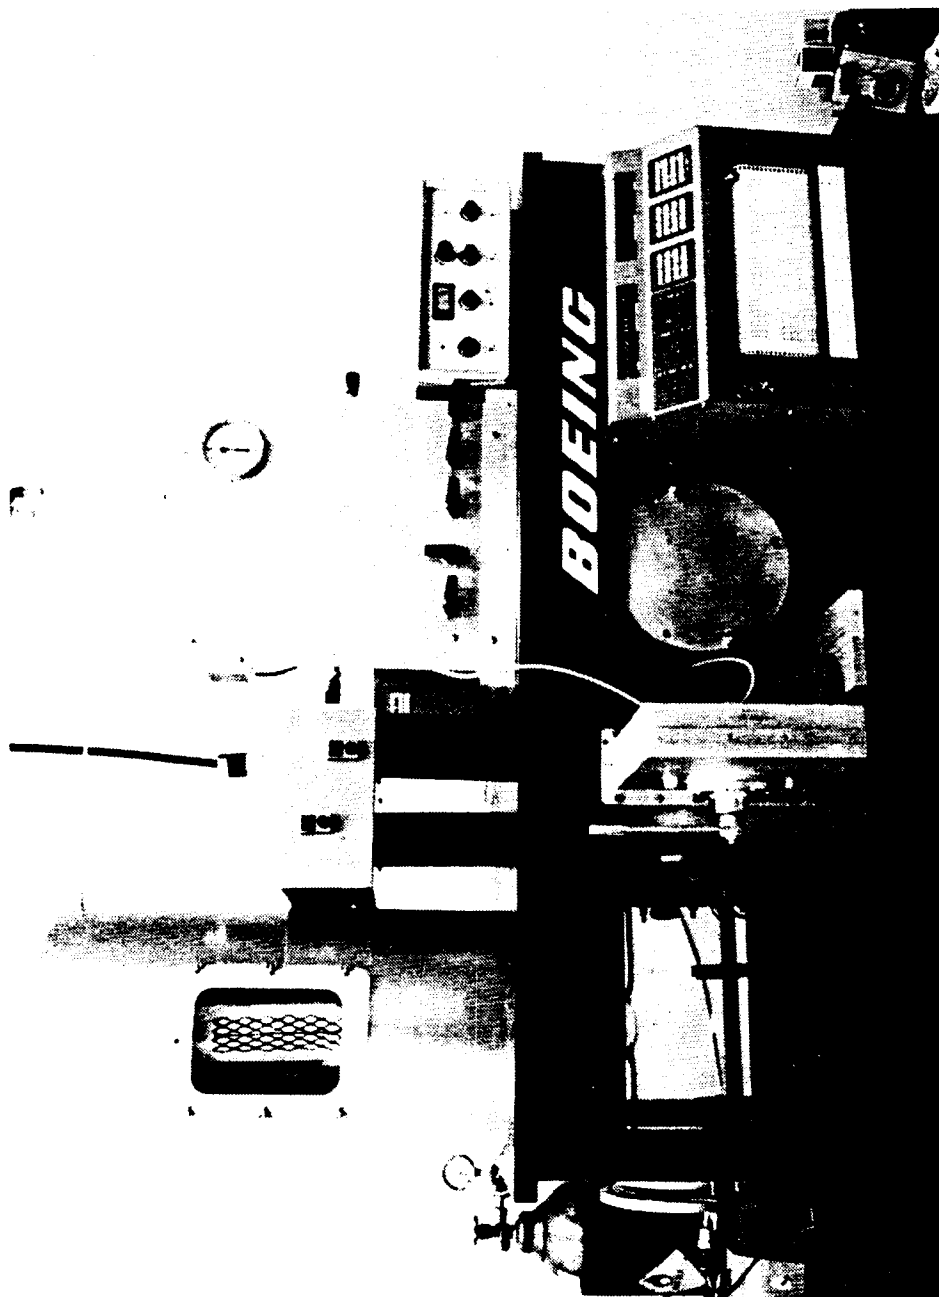
Figure 2. Current Configuration of A0 Test Apparatus

Figure 2 is a picture of the current test apparatus.

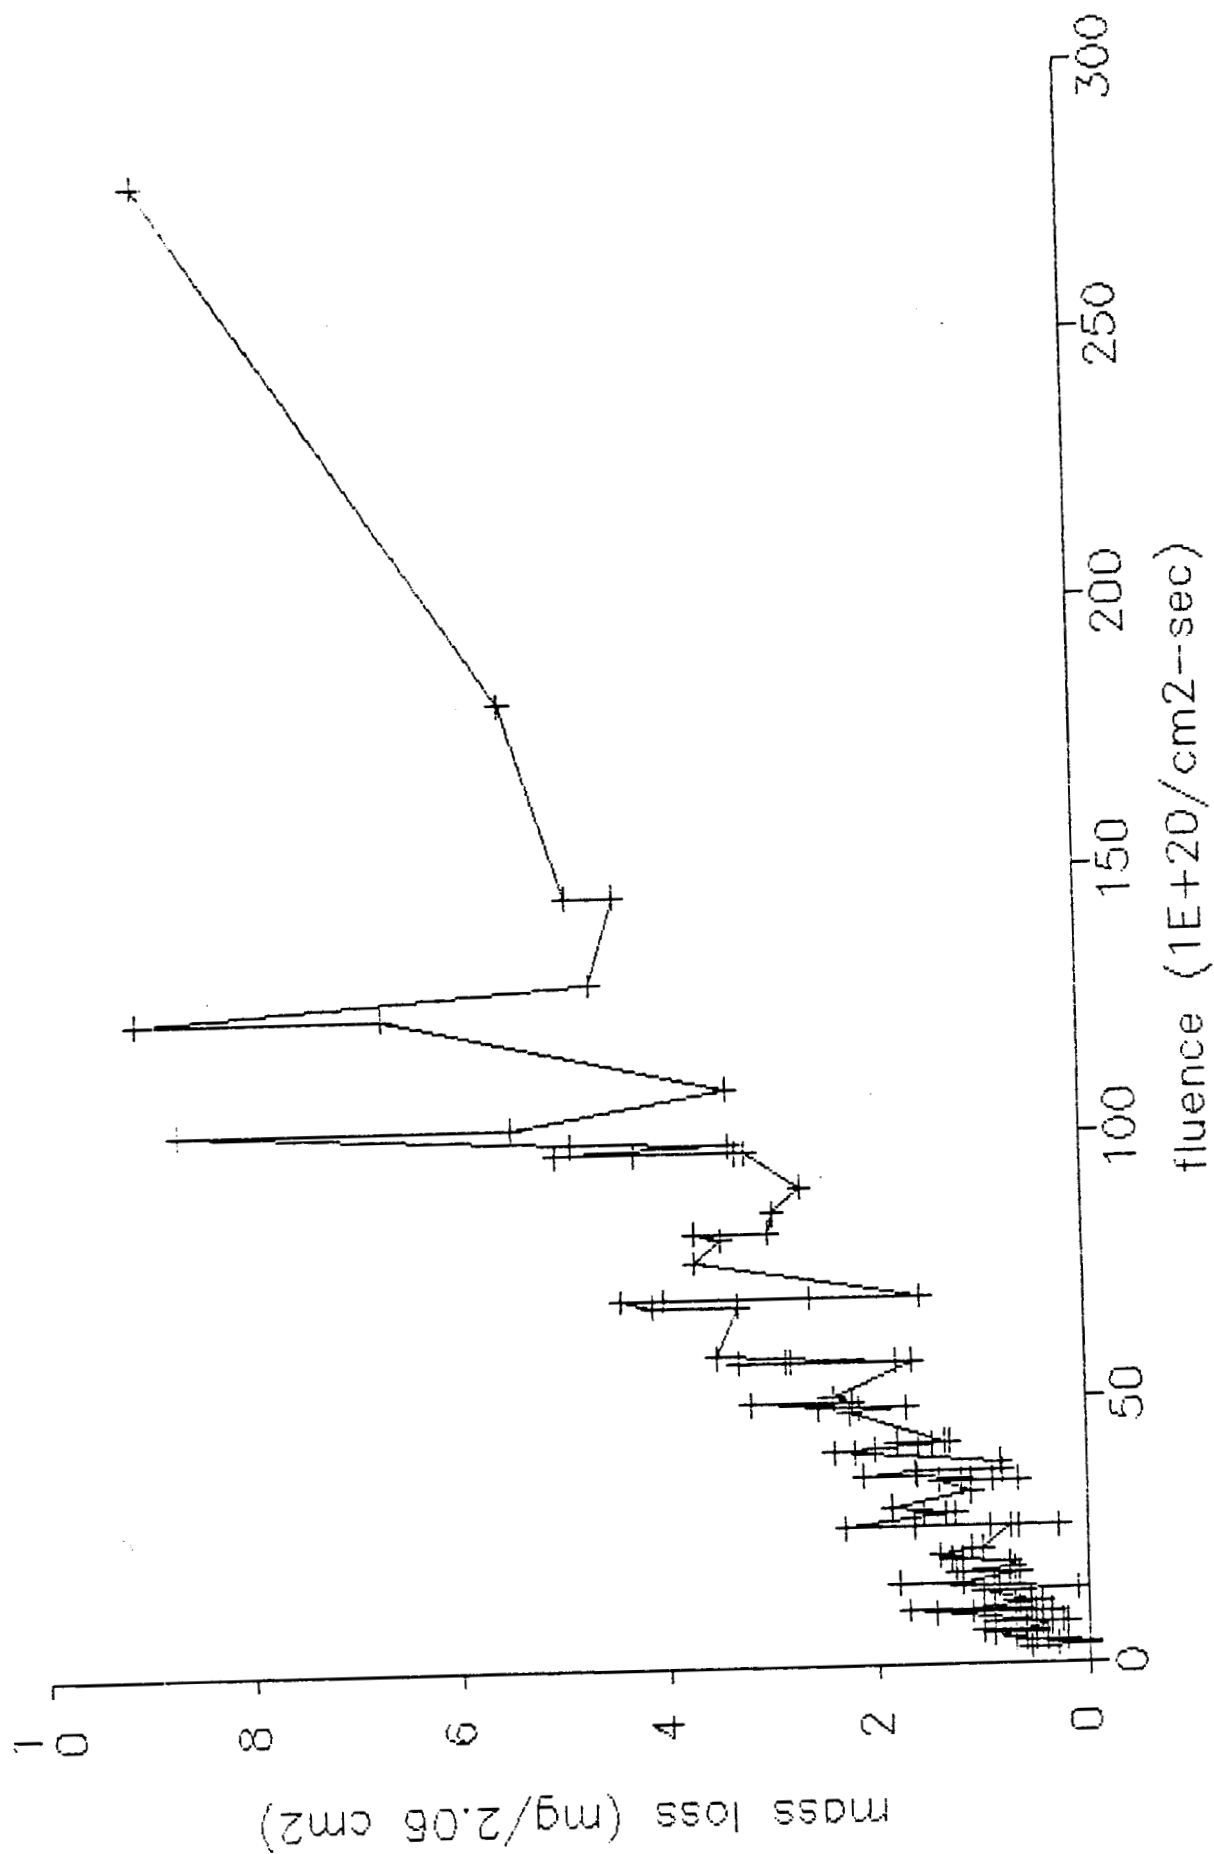
Figure 3: Mass Loss of Kapton, Held at 850°C, vs. Fluence of Atomic Oxygen

Many measurements of mass loss under exposure to atomic oxygen have been made under this contract. Measurements were made at several different temperatures. Tables 6 through 10 show the results of these measurements. Figures 3 through 8 are graphical summaries of mass loss data for Kapton. There are many measurements on Kapton because this material was used as the reference standard. Mass loss measurements for coatings on Kapton are a measure of the effectiveness of these systems but are not necessarily true measures of the intrinsic resistance of the coating material because of the possibility that cracks in the coating allow the Kapton to be exposed and oxidized.

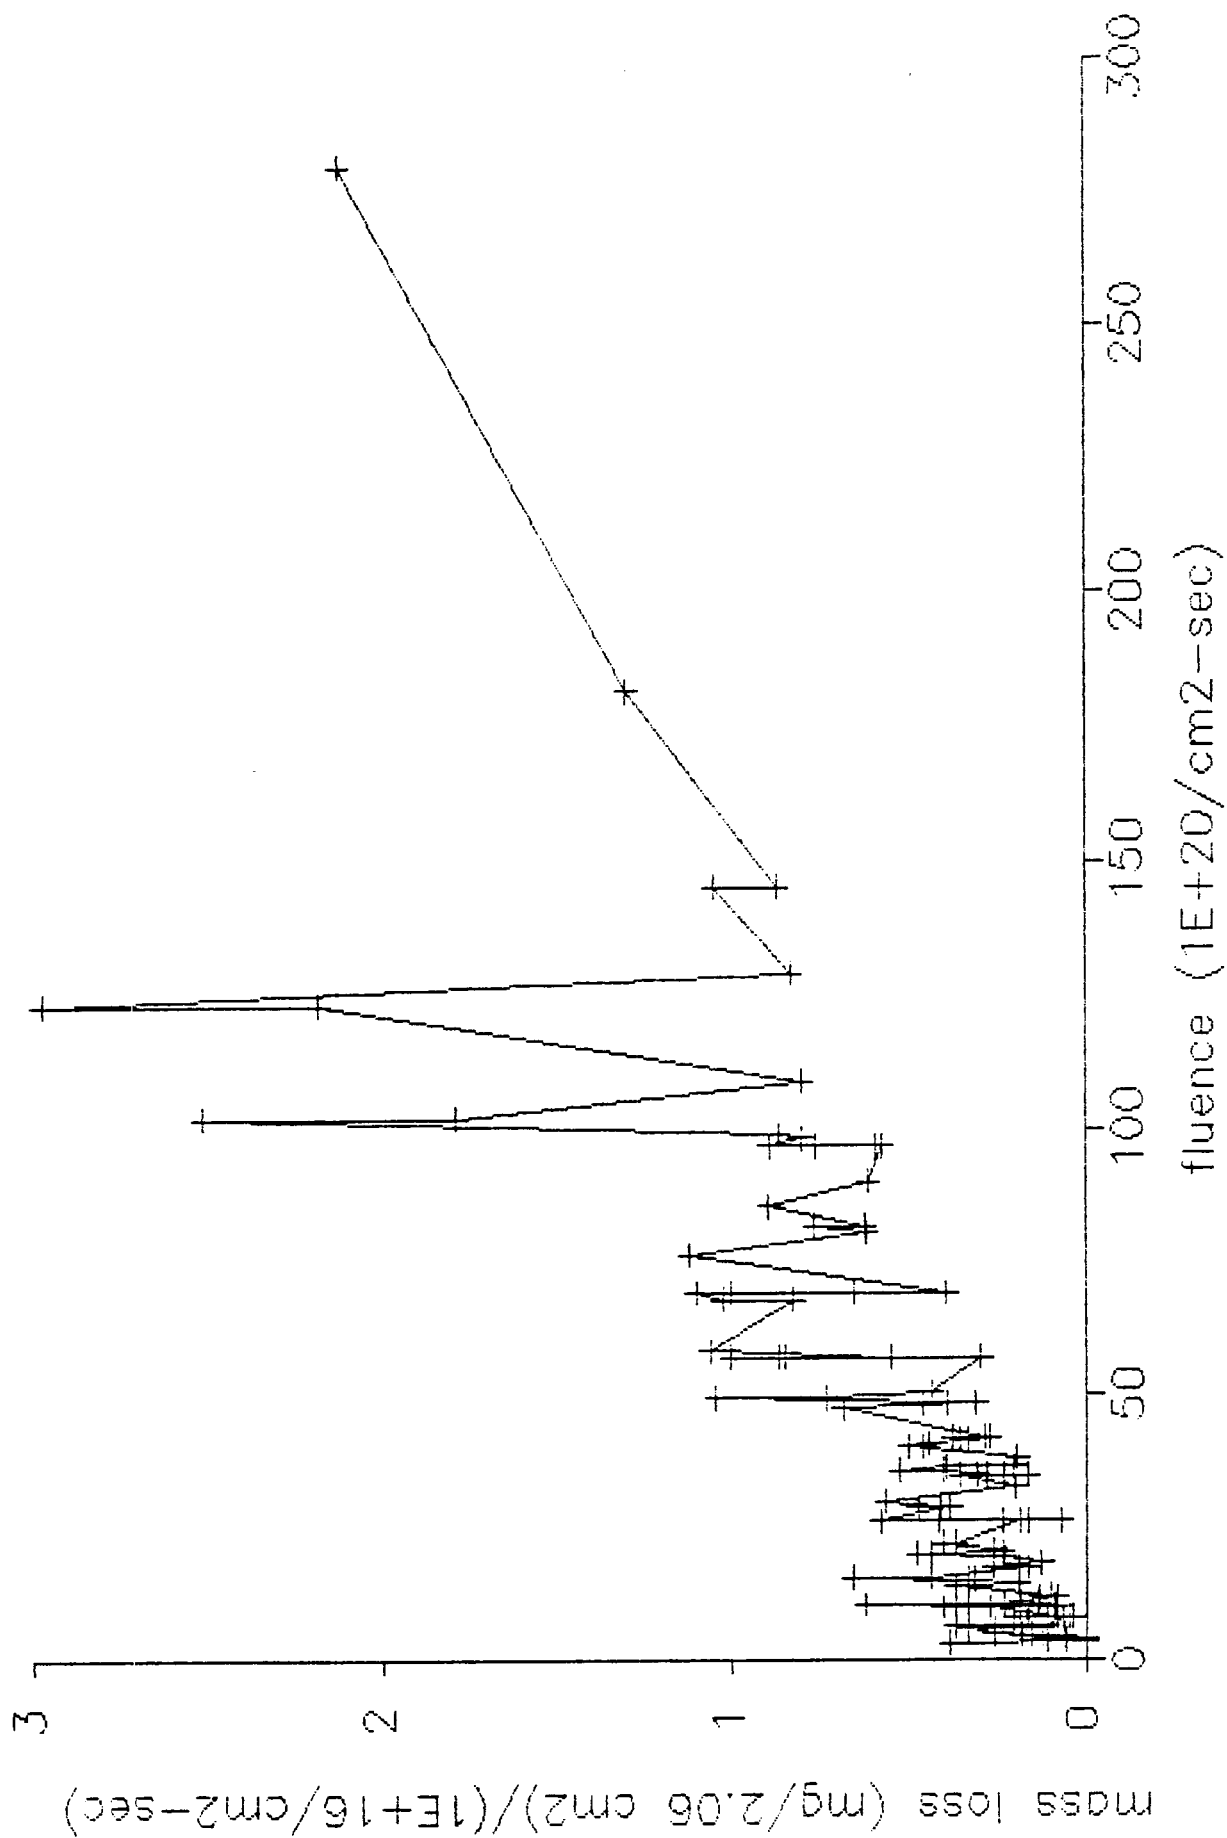
Figure 4: Mass Loss of Kapton, Held at 850C, per Flux of Atomic Oxygen vs. Fluence of Atomic Oxygen

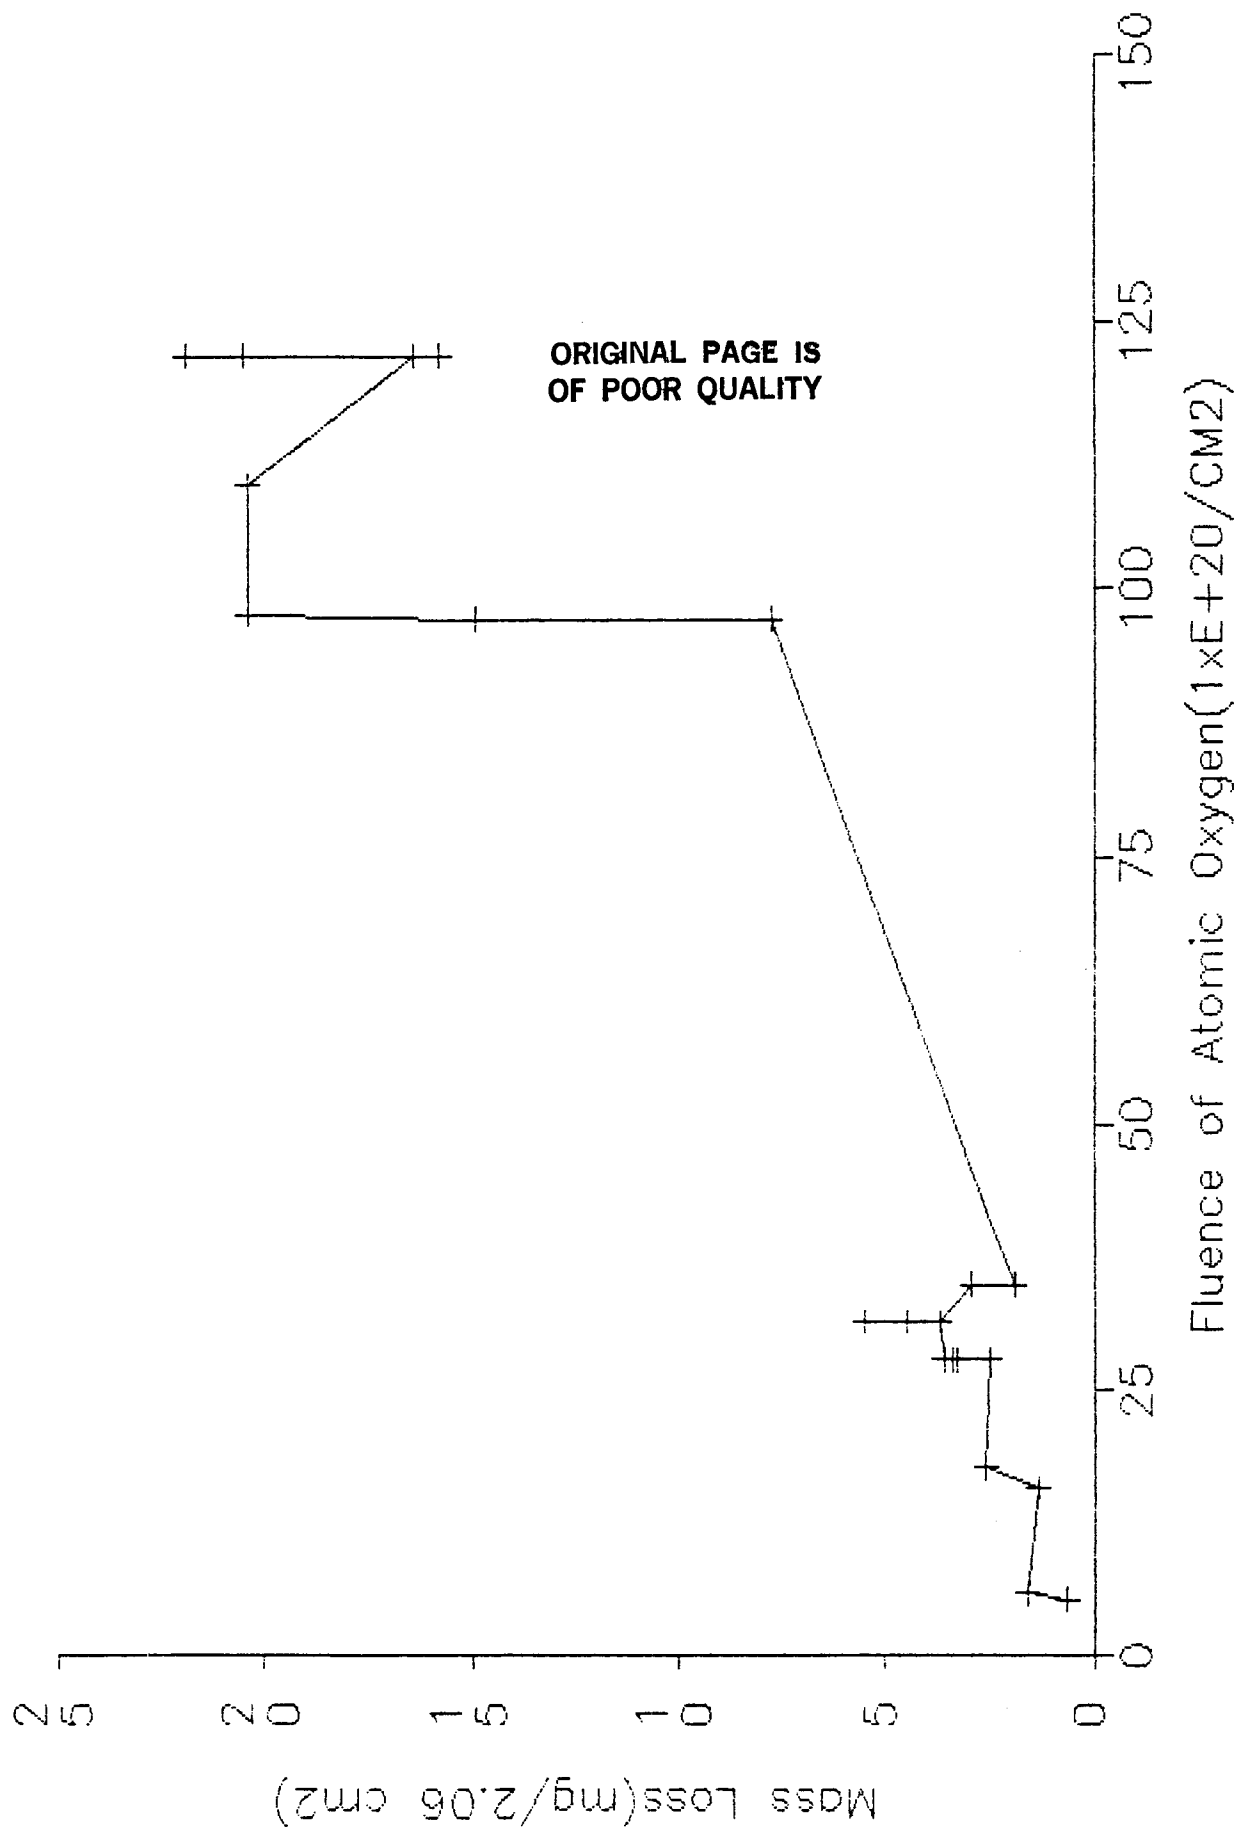
Figure 5: Mass Loss of Kapton, Held at 1000°C, vs Fluence of Atomic Oxygen

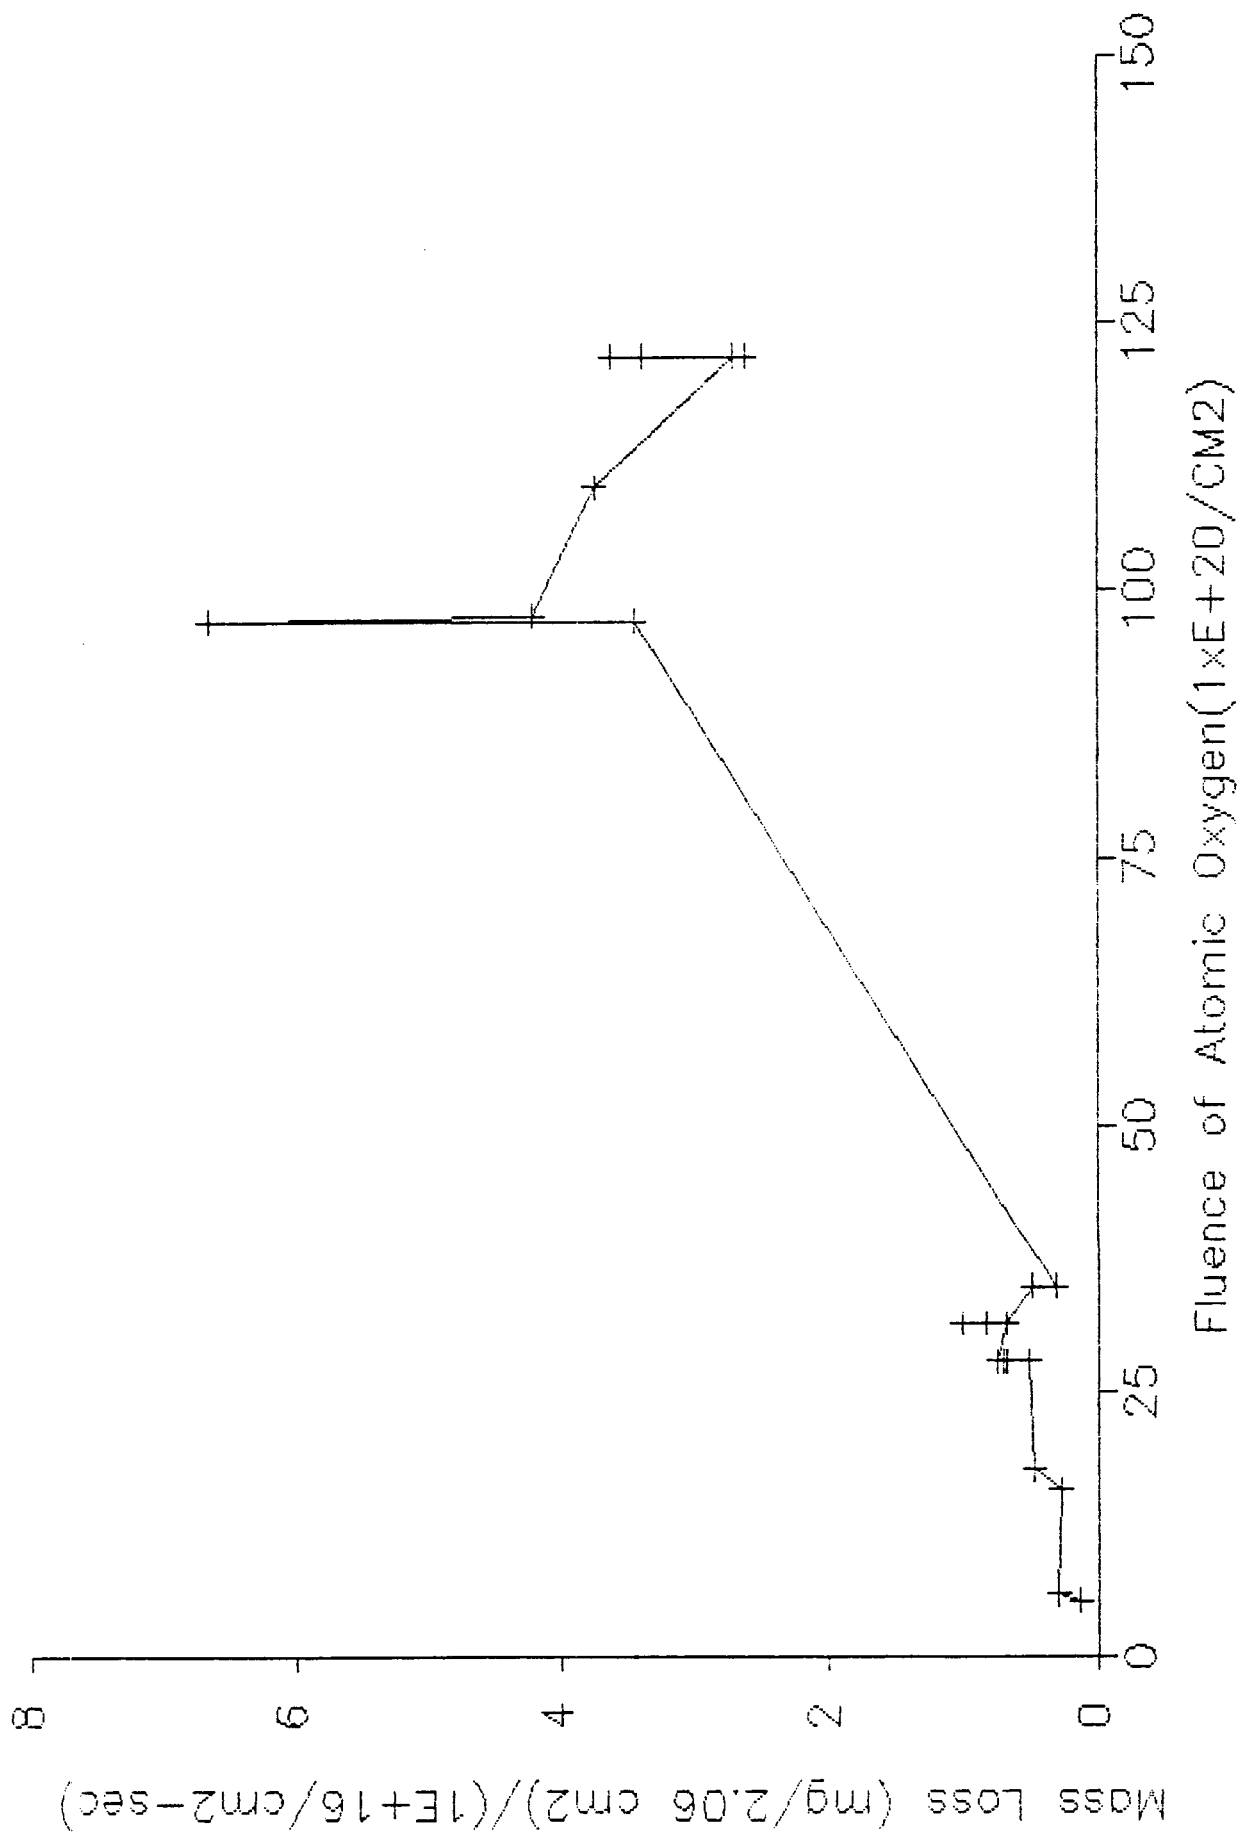
Figure 6: Mass Loss of Kapton, Held at 100°C, Per Flux of Atomic Oxygen vs. Fluence of Atomic Oxygen

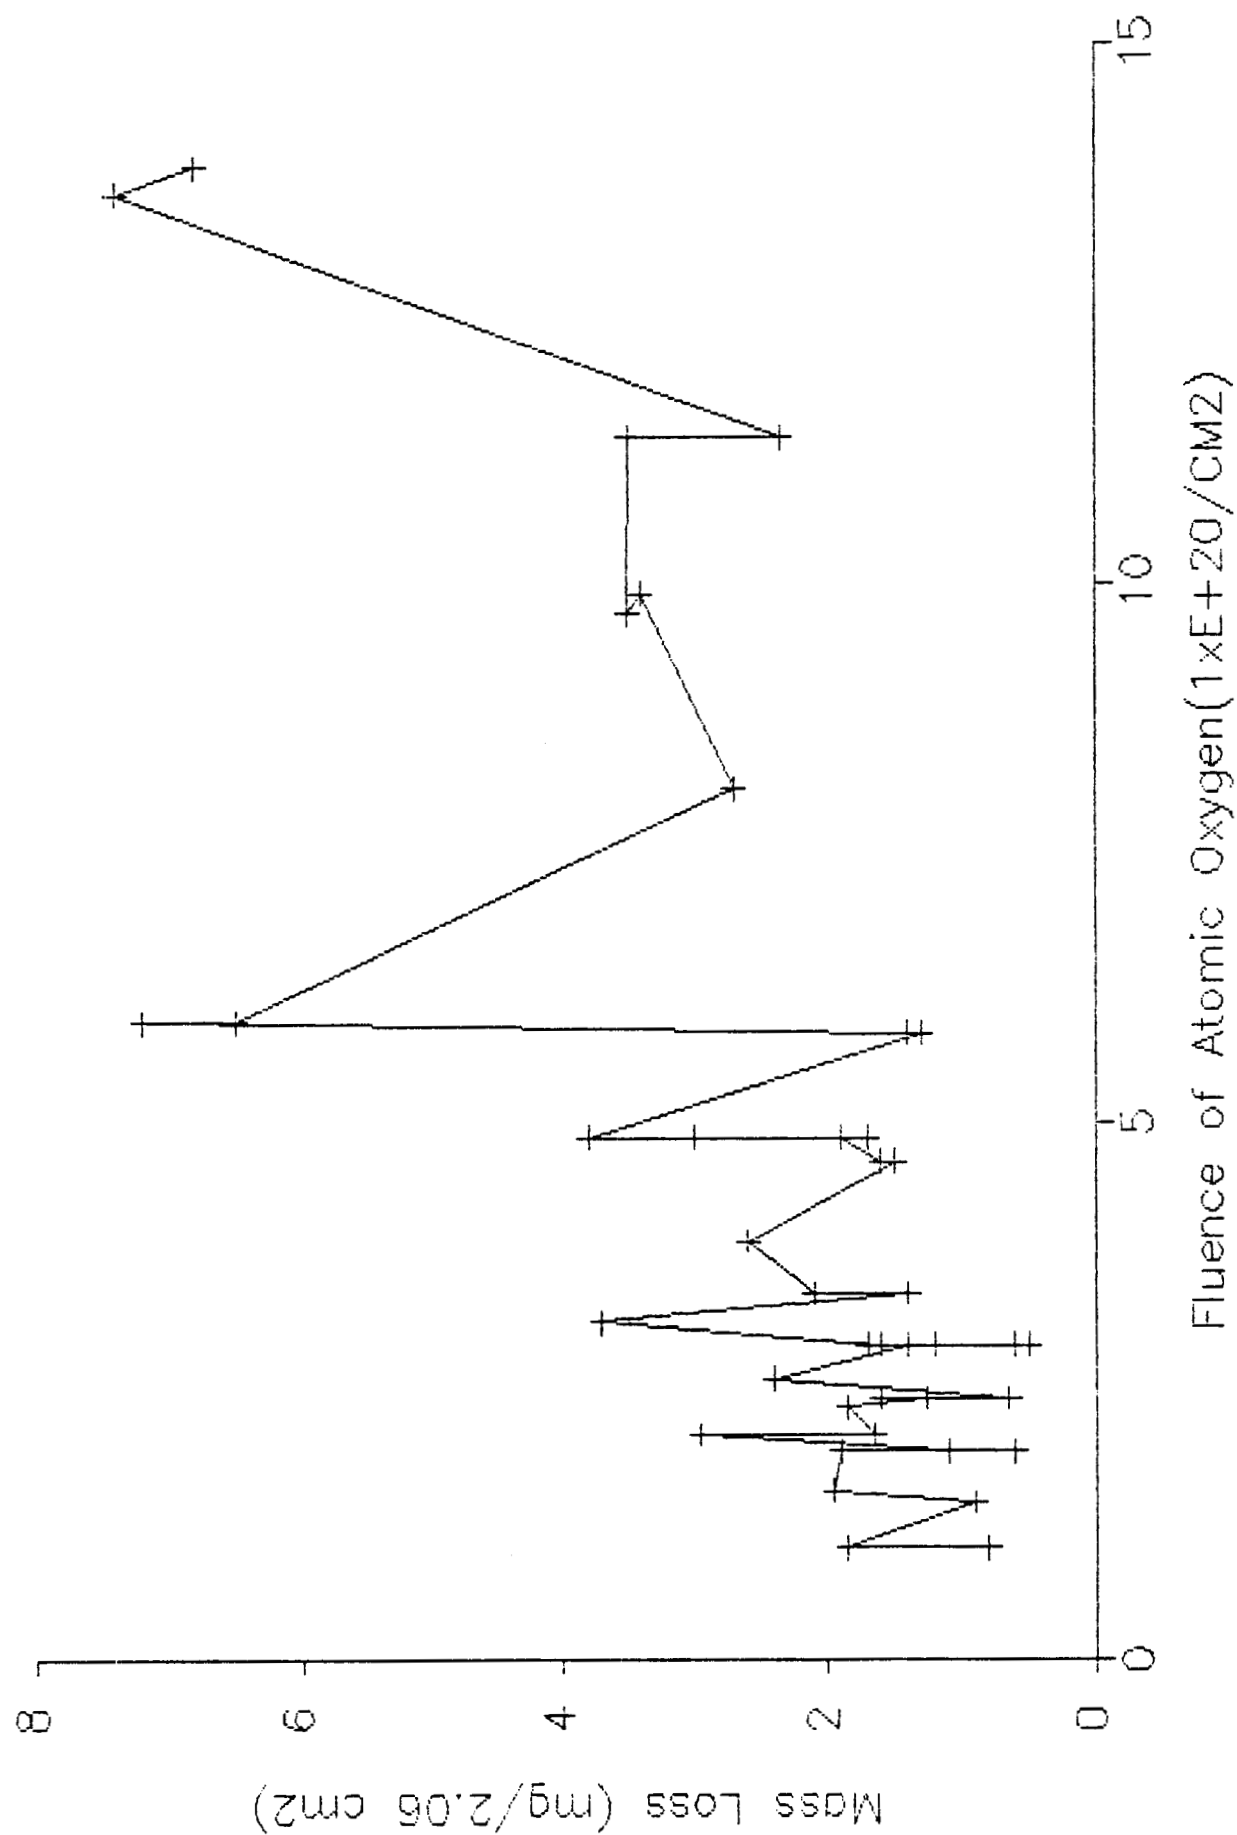
Figure 7: Mass Loss of Kapton, Held at 195°C, Per Flux of Atomic Oxygen
Per Flux of Atomic Oxygen

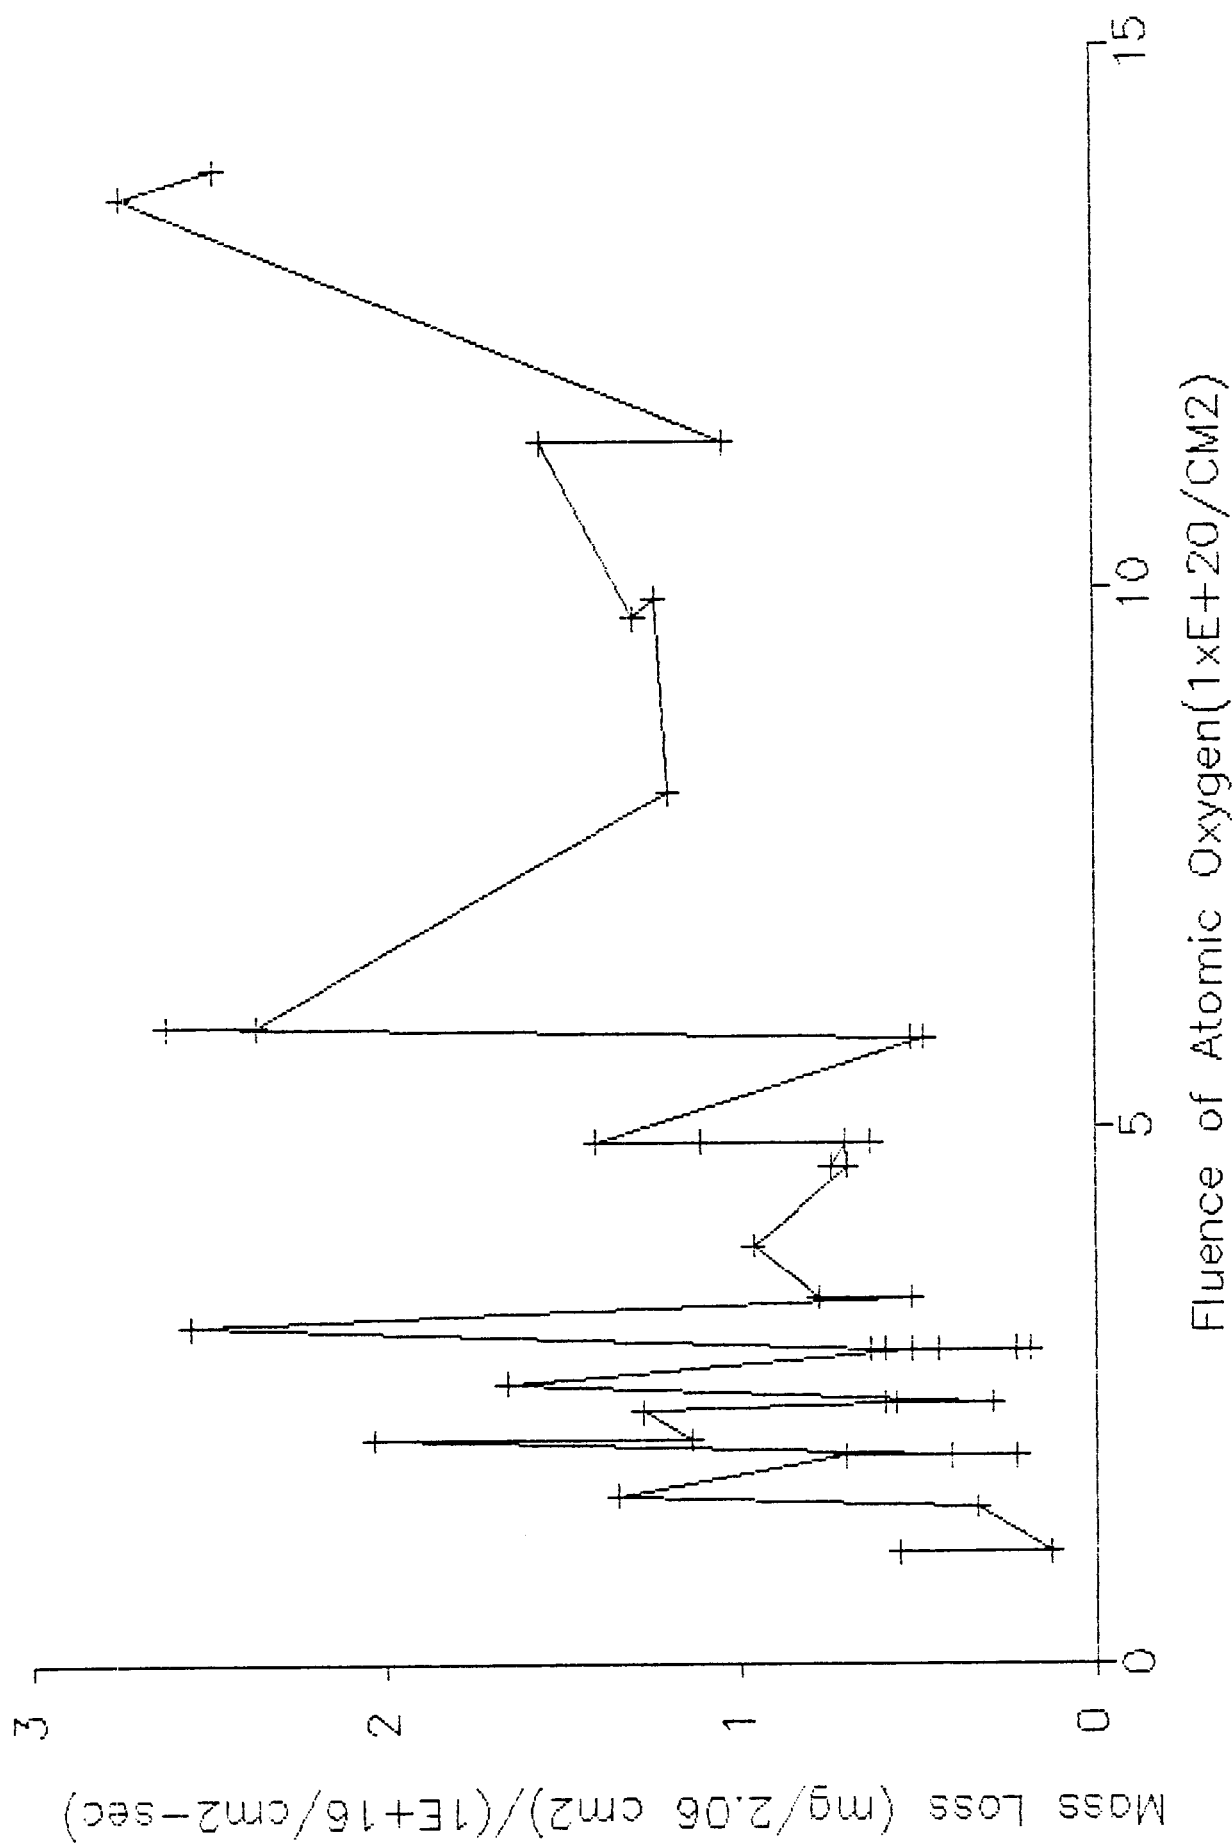
Figure 8: Mass Loss of Kapton, Held at 195°C, vs. Fluence of Atomic Oxygen

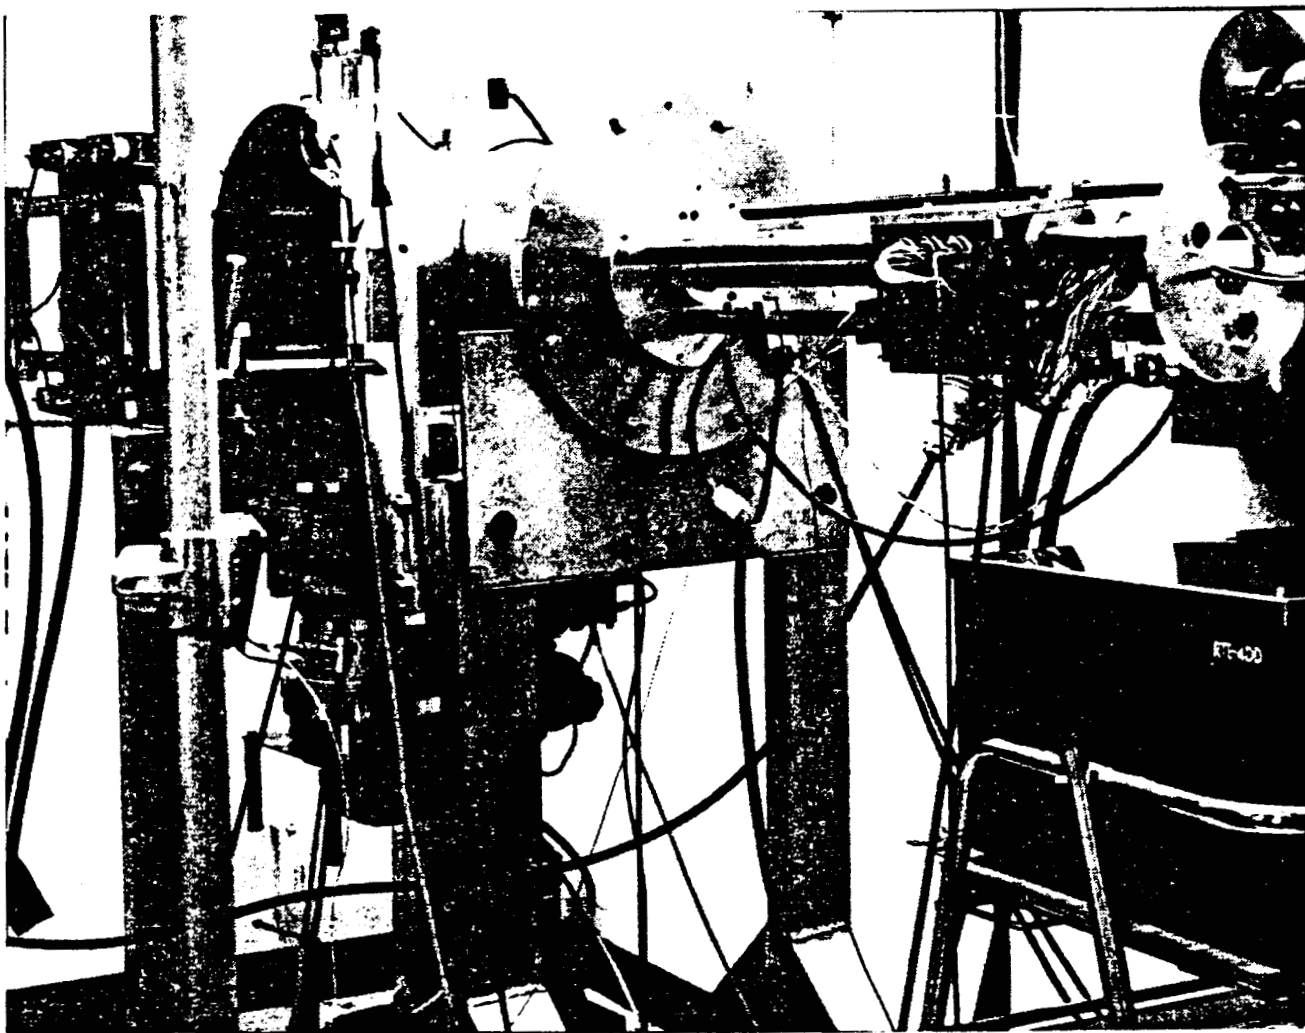
Figure 10: Vacuum Test Chamber With IR Lamp Array Used For
Thermal Cycling Test

The combined vacuum thermal cycling/UV exposure testing was performed in a turbo-molecular pumped vacuum chamber shown in figures 9 and 10. The sample holder frame was connected to a motor driven shaft which moves the samples between the cooling chamber and the window area.

The UV portion of the test was performed by moving the samples to the window area and adding a water window to the outside of the chamber (see figure 10). The UV source is a Spectrolab X25L solar simulator. The UV intensity was measured with a Hy-Them Pyrhelimeter manufactured by Hy-Cal Engineering. The UV content was set by mounting the pyrhelimeter on the sample plane and passing the X-25L beam through the water window. During the ultraviolet testing, the samples were moved to the thermal cycle "heat" position, a second quartz "water window" was attached to the vacuum chamber and the X-25 solar simulator was started. (The "water window" was necessary to reduce the infrared component of the solar simulator spectrum.)

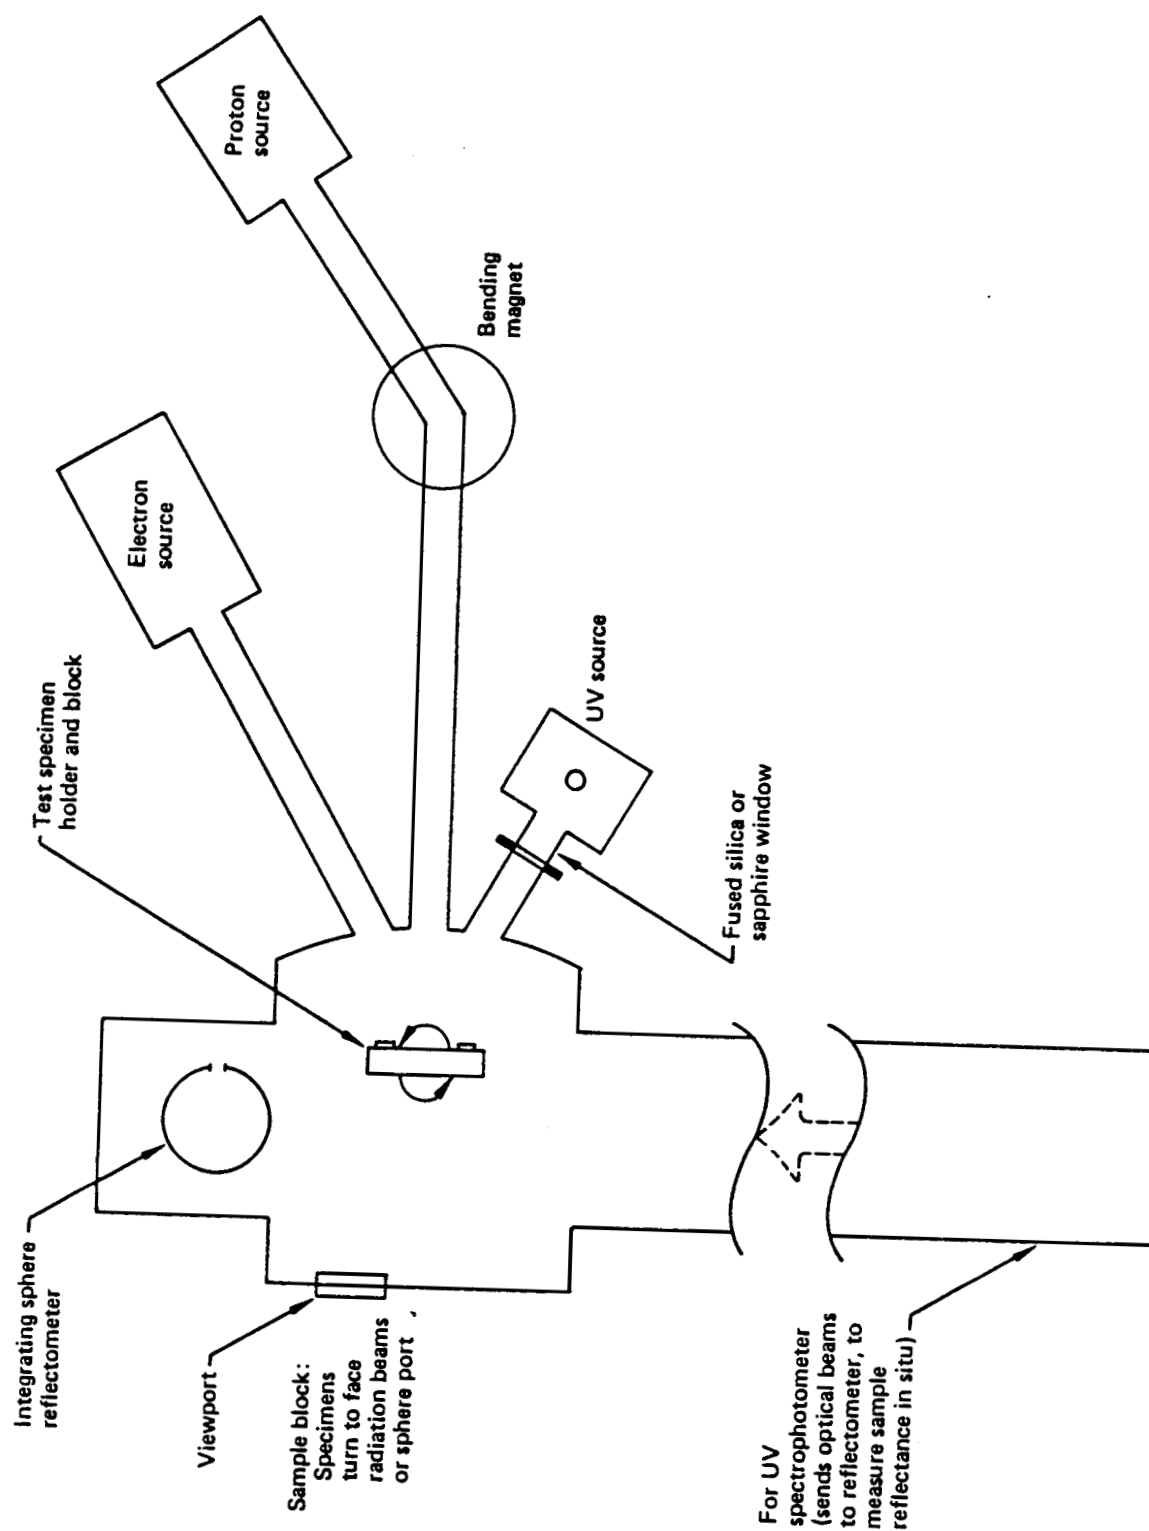
Figure 11: Schematic of Boeing Combined Radiation Effects Test Chamber (CRETC) II

Two tests were carried to determine the effects of combined proton, electron and UV exposure on coating optical properties. The facility used is shown schematically in figure 11 and a photograph is shown in figure 12. Three elements of the low earth orbit radiation environment were simulated under vacuum. Absorptance measurements were made periodically under vacuum during the course of the test run. To make the absorptance measurements the radiation sources shown in figure 11 are shutdown and the specimen block holding

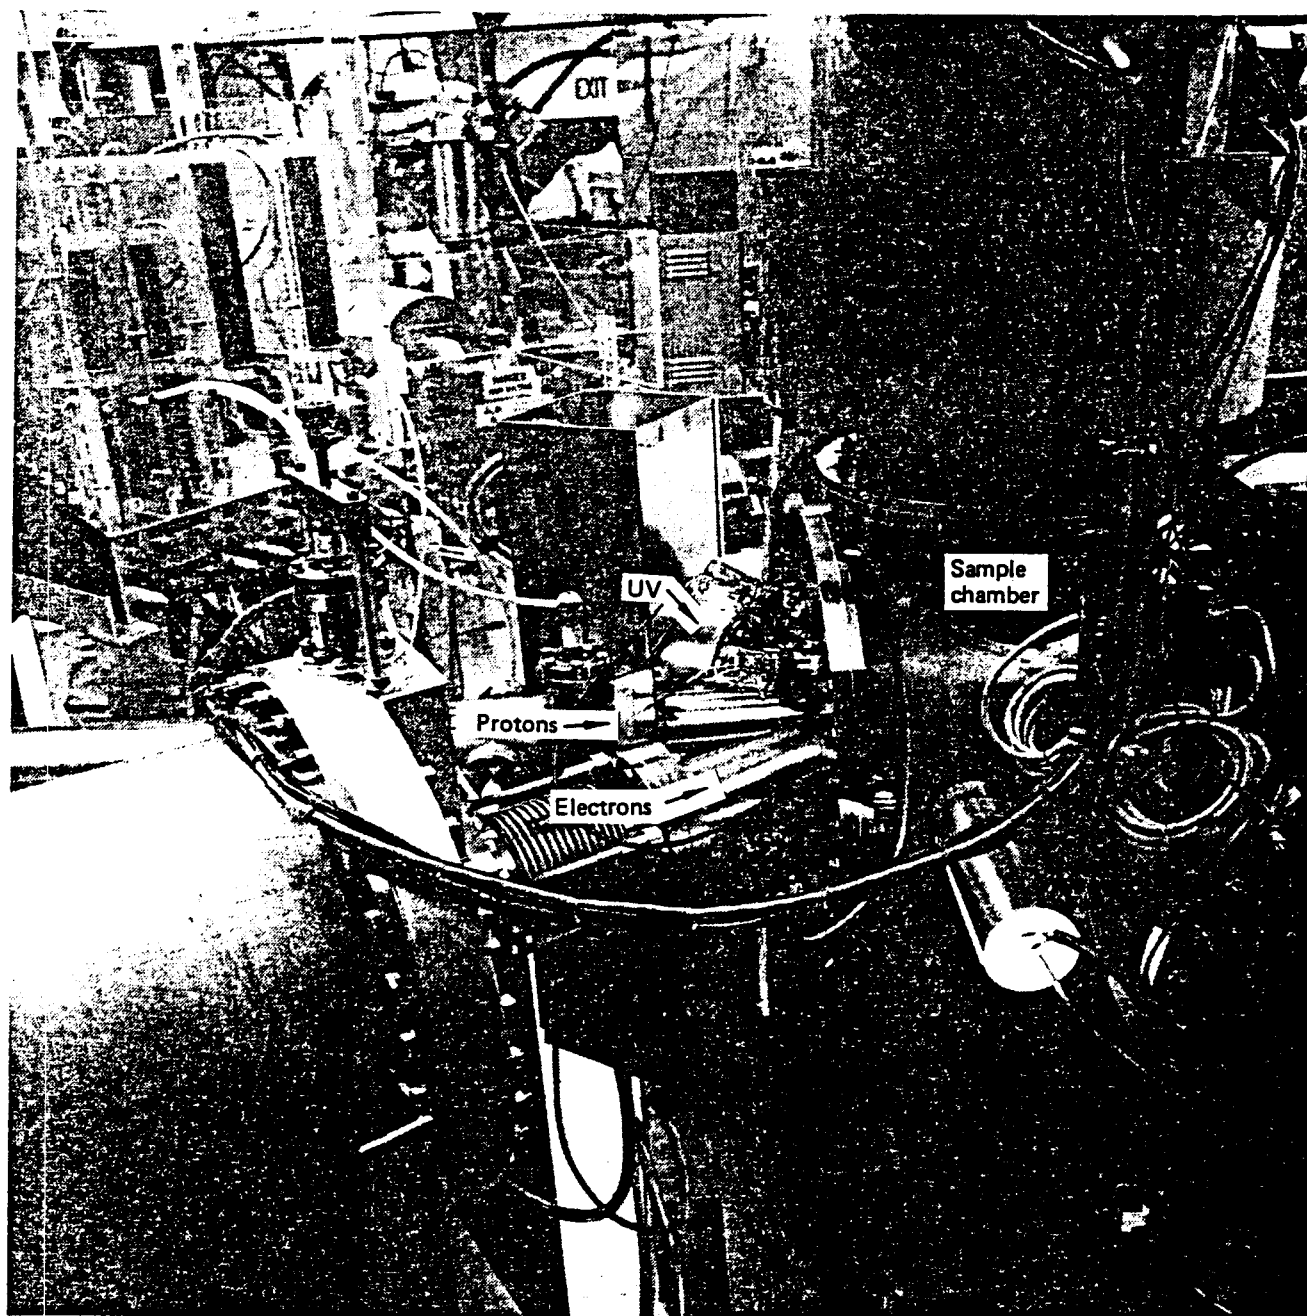
Figure 12: Photo of Boeing Combined Radiation Effects Test Chamber II
